# Stephen's Brae, Inverness

17 Oct 2020

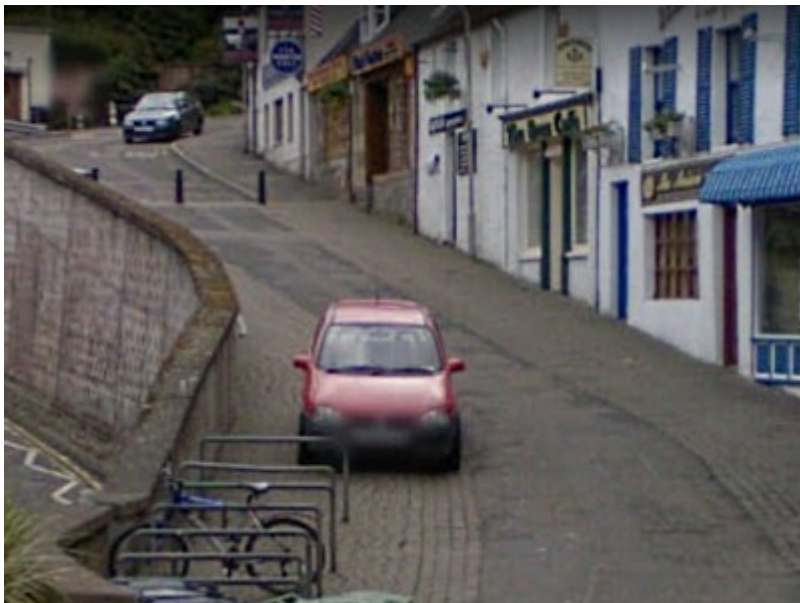
## Looking Back, 2008

Although steep, Stephen's Brae, Inverness, is a popular active travel route between the south-east of Inverness and the centre. It's on NCN 1. This view (from Google Streetview) shows how it was in June 2008. There were two footways and three bollards prevented through-traffic by motor vehicles.

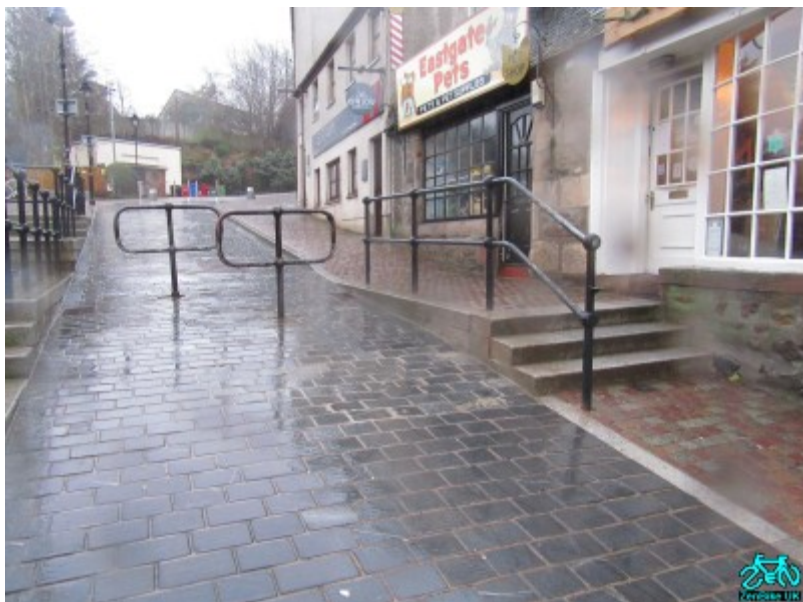
## Barriers in Position

One footway was lost when it was replaced with stone cubicles used informally as alfresco extensions for the businesses opposite. A new, short flight of three steps was introduced into the footway in front of the businesses. The bollards were replaced by two offset, staggered barriers.

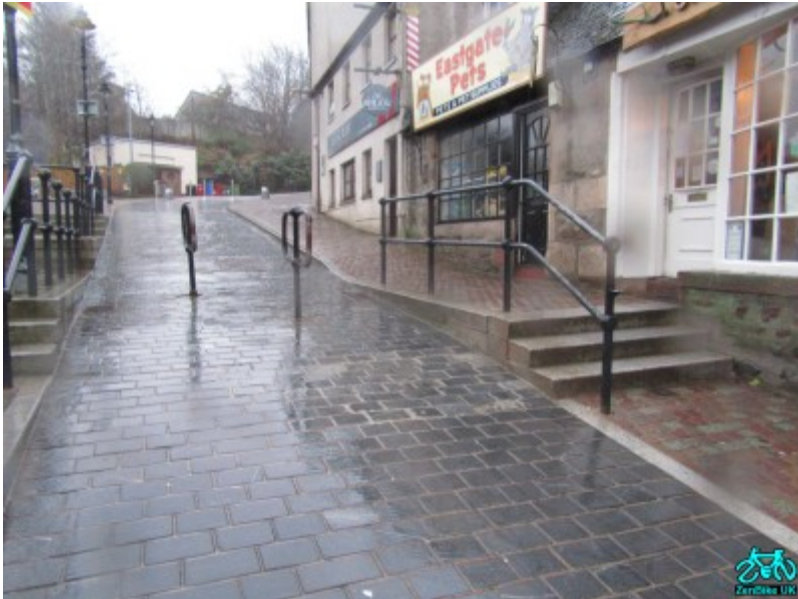
## Barriers Turned

The barriers are normally locked across the route creating a chicane to slow down speeding cyclists. But they can be unlocked and turned for parades etc and fully removed for emergencies. It should be noted that the barriers are across the road. It's footway space that is limited at this pinch point.

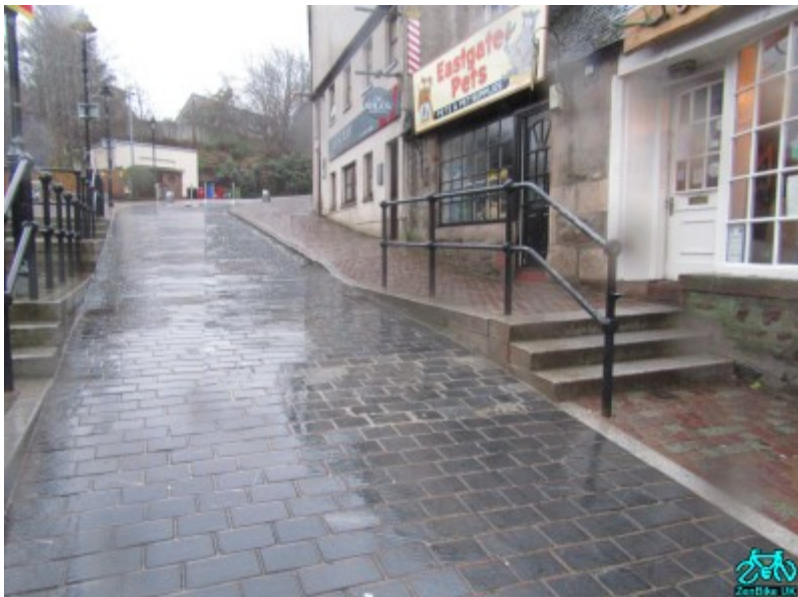
## Barriers Removed

On the rare occasions when the barriers are removed there is plenty road width for cycles, buggies, trailers, etc. Pedestrians unable to use the steps have no choice but to transfer to the roadway. Treating it as shared space is more of an issue for pedestrians.

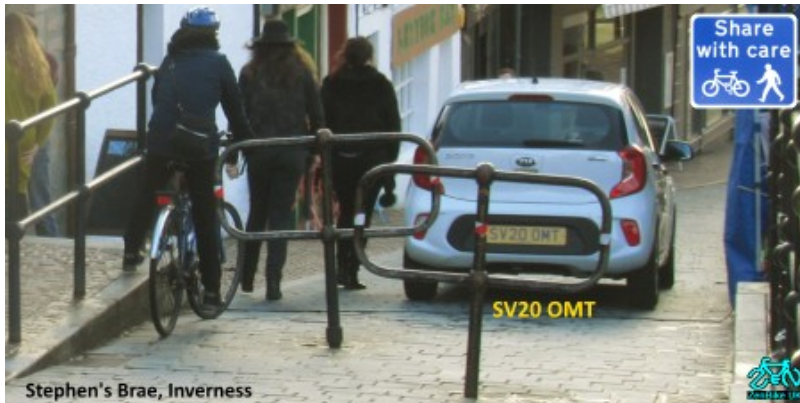
## Share with Care!

'Share with Care' signs have been added recently. These try to pass the responsibility on to walkers, wheelers, and cyclists. Meanwhile the real problem is the barriers, footway clutter, and parked motor vehicles. The need for COVID-19 distancing makes this more important.

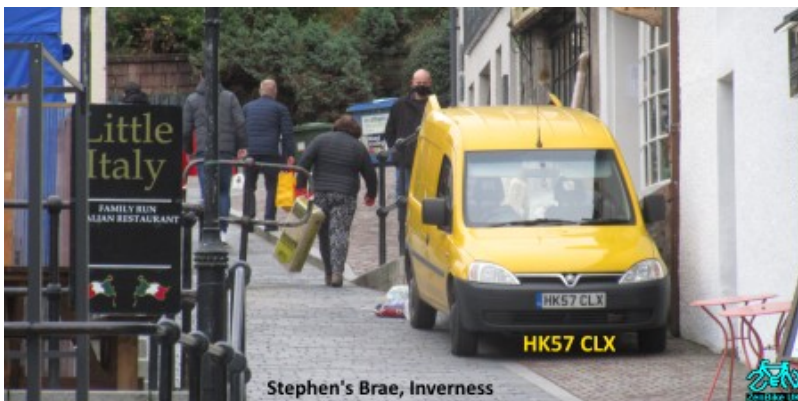
## Gradual Takeover

One original footway is gone. The remaining one is gradually being taken over by advertising boards, tables, chairs, shop display items, and parked cars/vans. [Loading is legal at set times - but this should not condone parking on the footway.]
